Cradle Mountain Water Dam Portfolio Risk Assessment

**ENTURA-6664B
August 2013**

*Extract from Cradle Mountain Water
Dam Portfolio Risk assessment*

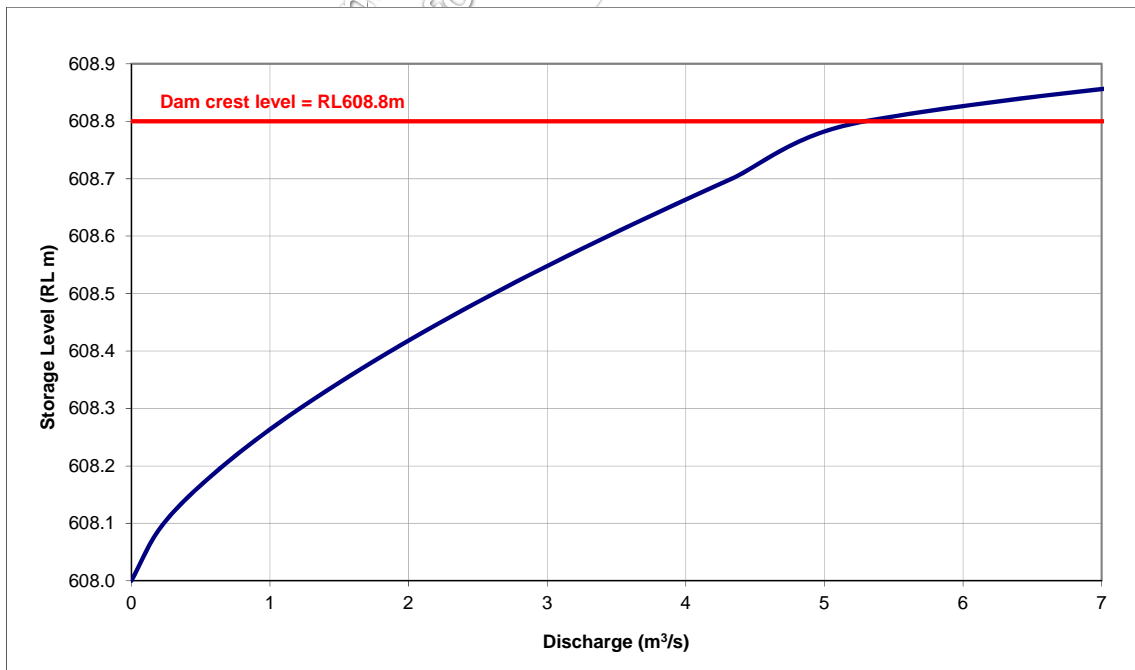
Figure 2.3: Waratah Dam – spillway rating curve (from Byleveld & Smyth, 2010)

- There is no record of flood overtopping the dam crest since the dam was repaired in 1976, and no signs of overtopping were visible during recent inspections. In addition, based on the size of the reservoir, there is likely to be a significant attenuation of flood inflow within the storage. Therefore, it is believed that the previous assessment by Byleveld & Smyth (2010) is likely to have underestimated the spillway capacity.

- The flood hydrology used for the risk assessment was based on a preliminary study undertaken by Byleveld & Smyth (2010) based on the *Tasmanian Regional Method*. A more detailed hydrology assessment is recommended to enable a better estimation of the flood overtopping risk. In addition, a detailed survey and hydraulic modelling of the spillway is recommended to improve the spillway rating estimate.

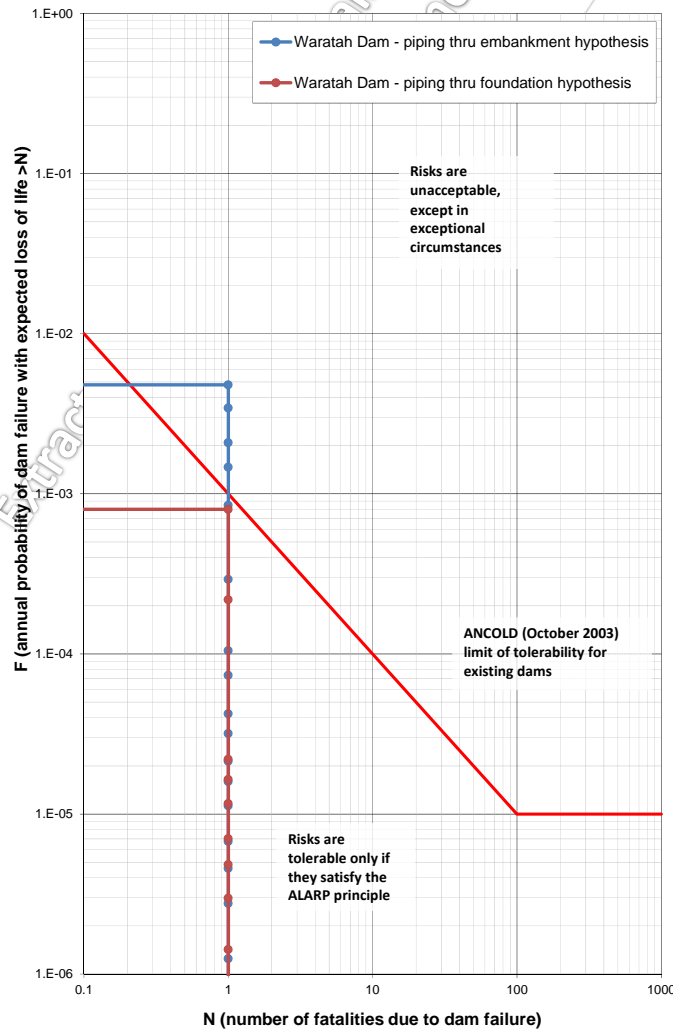
Figure 2.4: Waratah Dam – societal risk against ANCOLD societal risk guideline for existing dams

The societal risk of Waratah Dam is presented in Figure 2.4 against the ANCOLD (2003) criteria.

It is noted that at Waratah Dam the weighted PLL is less than 1 (i.e. 0.1 and 0.18 for SDF and flood failure respectively). On the F-N plot, the PLL was assumed to be 1 person while the actual weighting values of the PLL were applied as a conditional probability to the annual probability of dam failure.

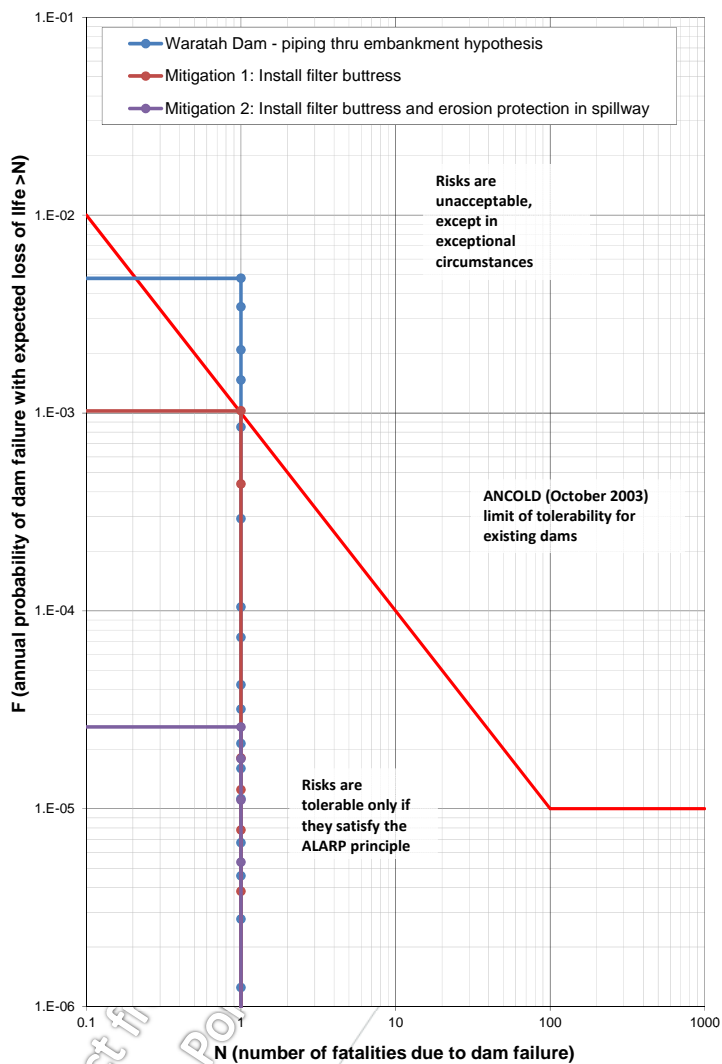
Figure 2.5: Waratah Dam – estimated societal risk post mitigation measures

The new estimated risk position of Waratah Dam post mitigation is shown in Figure 2.5 below.

Based on the current estimated risk position of Waratah Dam, the following risk mitigation measures are recommended to address the key failure modes:

- Undertake an investigation to confirm the sources of leakage.
- Mitigation 1: Install filter buttress.
- Mitigation 2: Mitigation 1, plus provide erosion protection along the spillway channel in the vicinity of the embankment.
