## 21 Evandale STP

### 21.1 Activity and report details

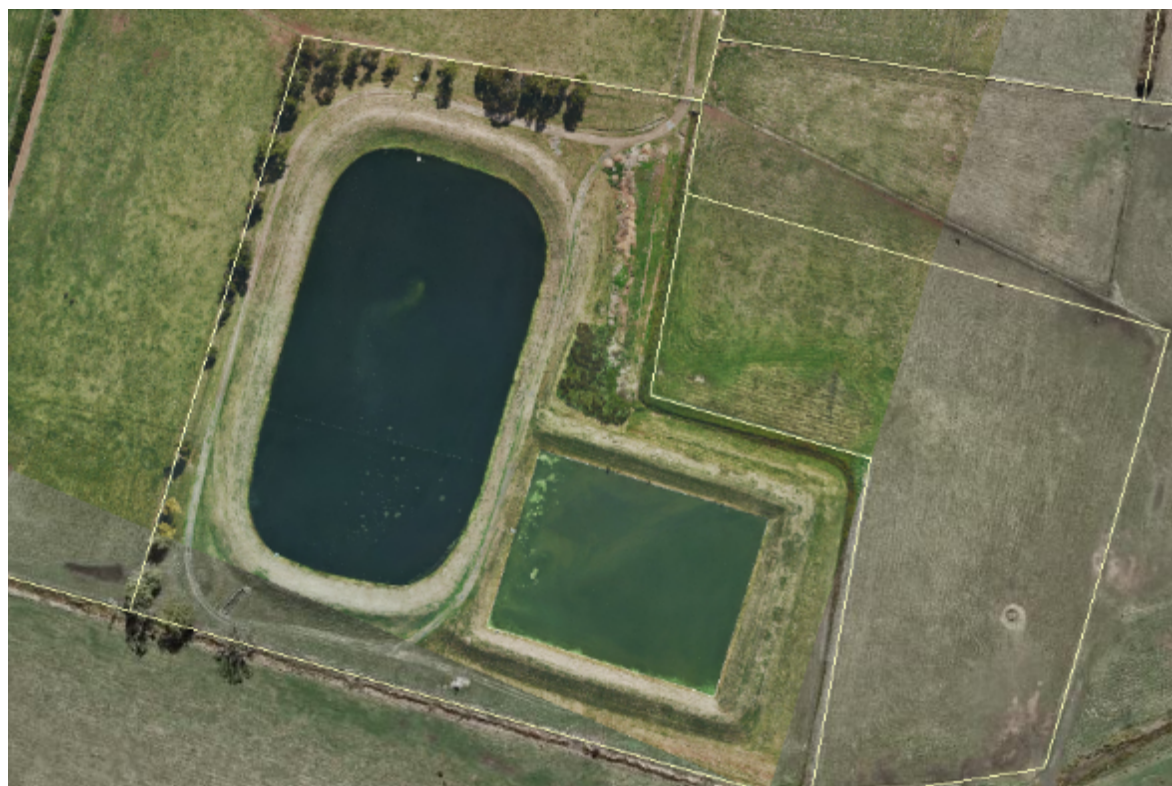
Figure 21-1: Evandale Sewage Treatment Plant
