Cradle Mountain Water Dam Portfolio Risk Assessment

**ENTURA-6664B
August 2013**

*Extract from Cradle Mountain Water
Dam Portfolio Risk assessment*

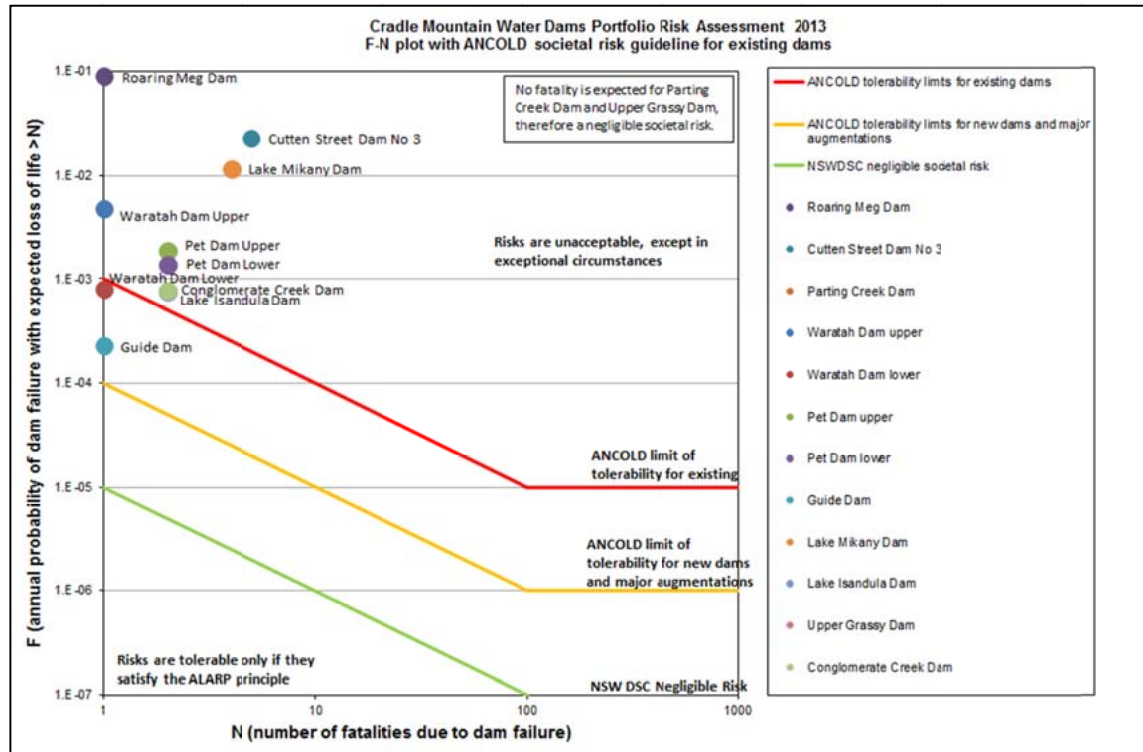
The societal risks for all dams in the portfolio are plotted against the ANCOLD (2003) limits of tolerability for existing and new dams. For better presentation and clarity of results, only the most critical F-N points for the dams are shown in the plot. The New South Wales Dam Safety Committee (NSWDSC) negligible risk line was also provided for reference purpose.

A number of remarks should be noted about this plot:

- Sensitivity analyses were undertaken for Waratah and Pet Dams (denoted by the “upper” and “lower” descriptions). While for Pet Dam, there is only a small difference in the risk positions. For Waratah Dam, the assumptions made have a significant impact on the dam risk position. This highlights the importance of further investigations for Waratah Dam to justify the risk assessment results.
- The societal risk for Conglomerate Creek Dam was adopted from the recently completed dam safety review (Neupane, 2012).

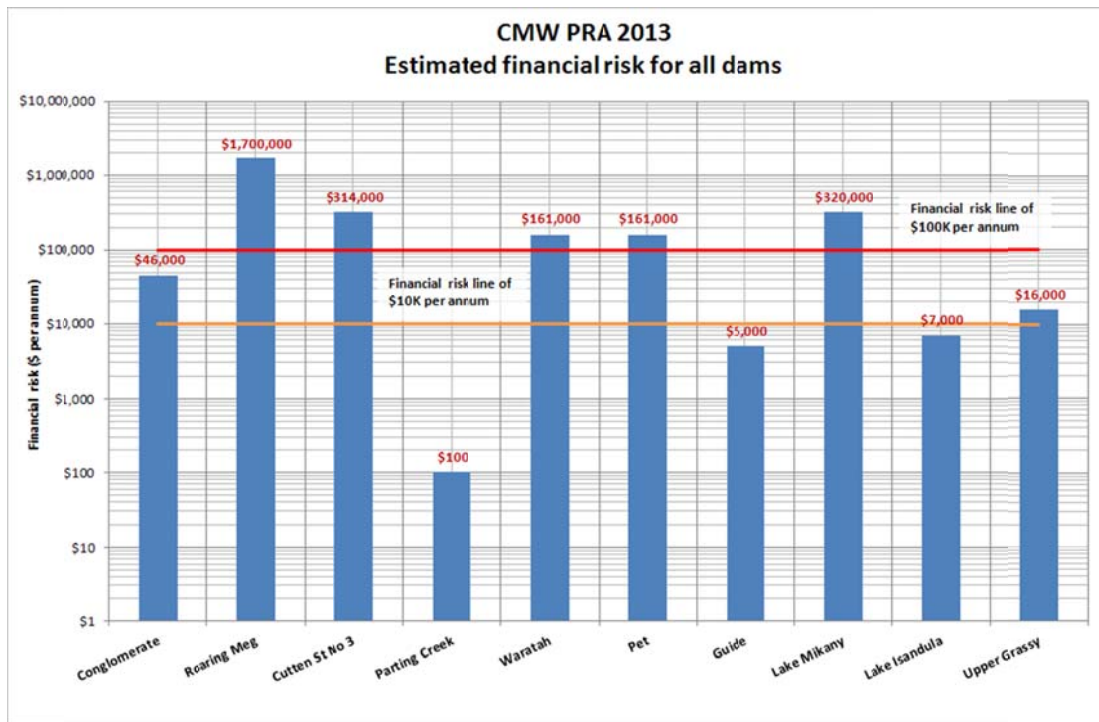
The following conclusions were made in regards to financial risks:

- Based on this assessment, Conglomerate Creek Dam, Roaring Meg Dam, Cutten Street Dam No 3, Waratah Dam, Pet Dam, Lake Mikany Dam and Upper Grassy Dam all have financial risk exceeding the \$10k/annum mark, which pose a significant risk to the business.
- Roaring Meg Dam, Cutten Street Dam No 3, Waratah Dam, Pet Dam and Lake Mikany Dam have the highest financial risk in the portfolio with estimated values exceeding \$100k/annum.
- The highest financial risk is from Roaring Meg Dam with \$1.7M/annum.
- Overall, these dams imply a total financial risk of approximately \$2.7M per year to CMW.

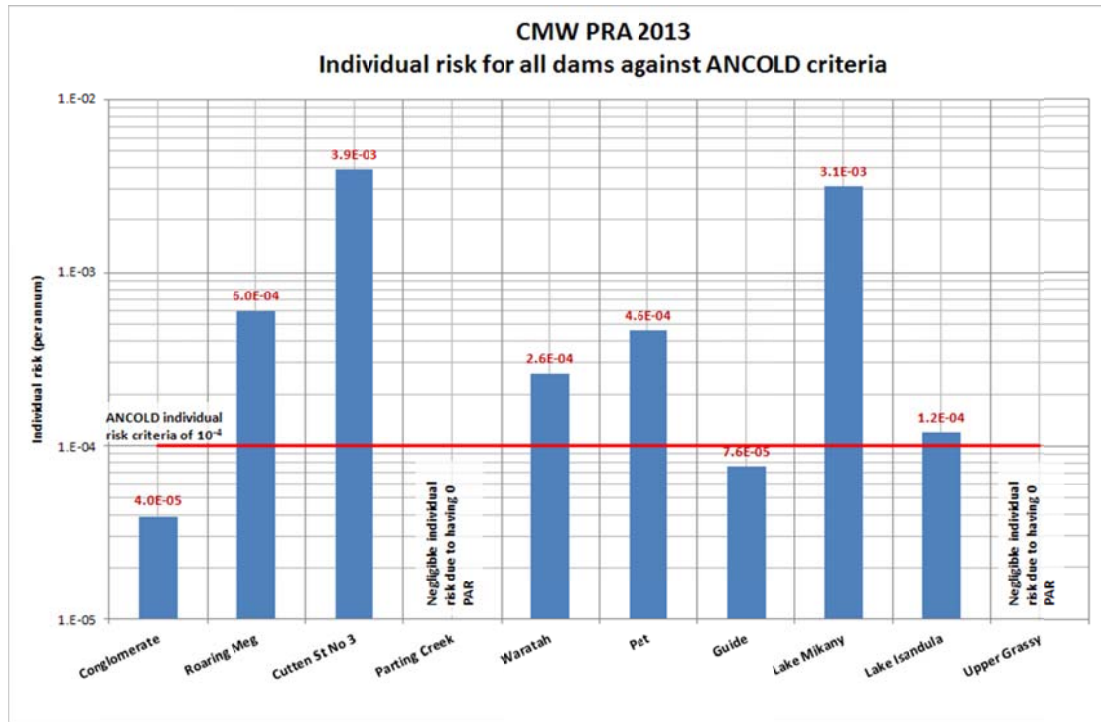
The individual risks for all dams are shown in the following figure. The following conclusions were made in regards to individual risks:

- The individual risk posed by Roaring Meg Dam, Cutten Street Dam No 3, Waratah Dam, Pet Dam, Lake Mikany Dam and Lake Isandula Dam are considered intolerable as they exceed the ANCOLD limit for individual risk of 10^{-4} per annum.
- Individual risk downstream of Conglomerate Creek Dam and Guide Dam are deemed acceptable.
- No individual risk is expected for Parting Creek Dam and Upper Grassy Dam as no population at risk (PAR) has been identified due to the failure of these dams.

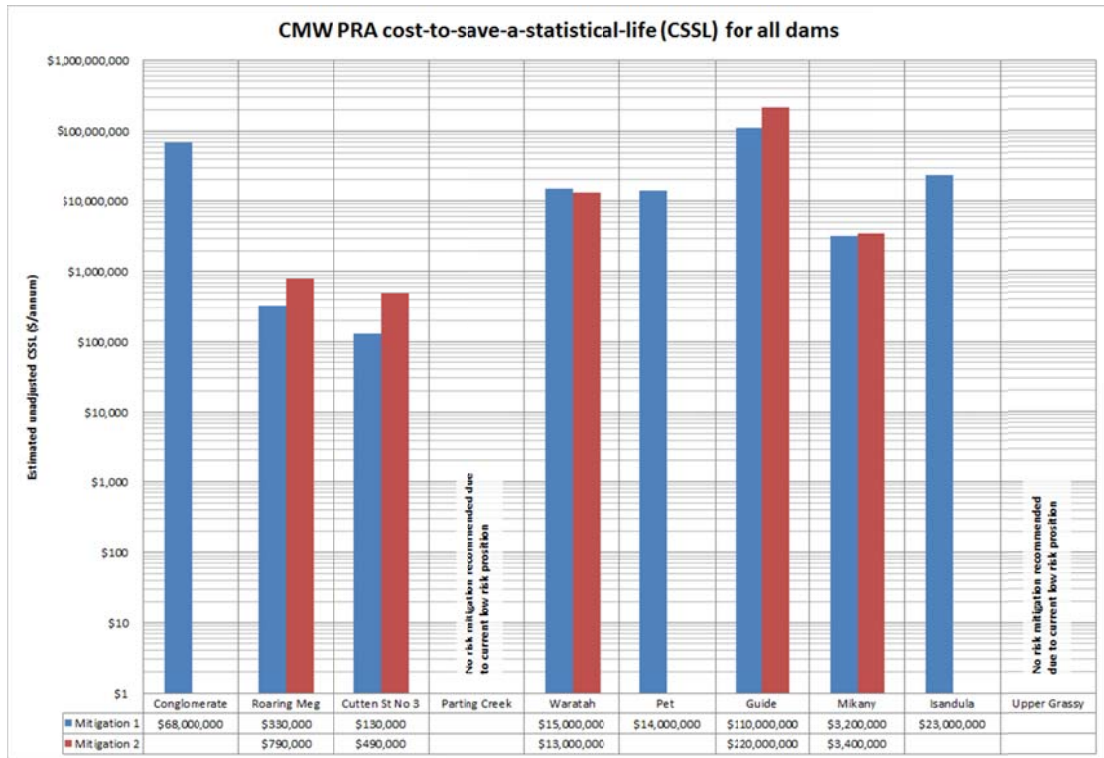
Based on the current risk positions of the dams, a list of investigations and mitigation measures are provided to mitigate and reduce the risk to align with the ANCOLD (2003) societal risk guidelines as summarised in the following table. The cost-to-save-a-statistical-life (CSSL) was estimated to assist with ranking and comparison of the mitigations in regards to the cost effectiveness of the options in reducing life safety risk. On this basis, the favourable options are highlighted in green and the less-favourable options are highlighted in red.

Dam	Mitigation 1			Mitigation 2		
	Description	Estimated cost (\$)	CSSL (\$/annum)	Description	Estimated cost (\$)	CSSL (\$/annum)
Waratah	Undertake an investigation to confirm the sources of leakage. Then install filter buttress if required.	\$930k	\$15M	Mitigation 1 plus provide riprap protection along spillway	\$980k	\$13M
